19518

2011-17 Chevy Cruze, 2013 18 Buick Encore L4-1.4L Turbo

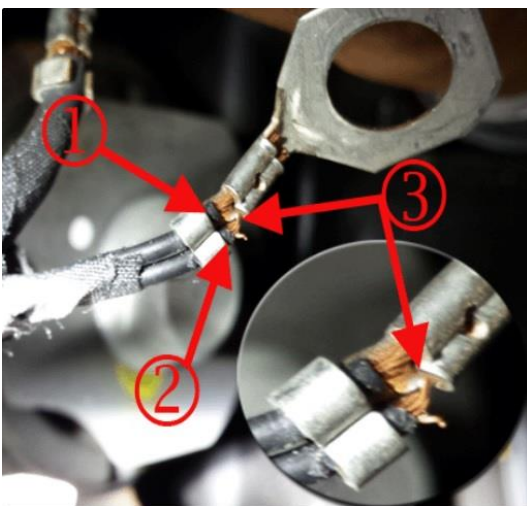
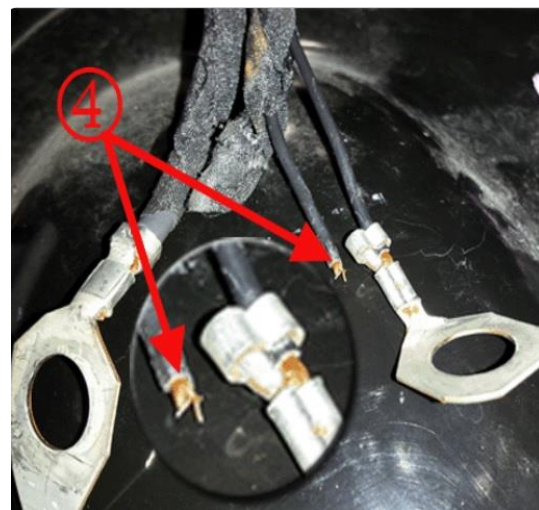
- Subject:** Premature Catalytic Converter Failures
- Condition:** PO420 & PO430 Codes. Catalyst Failure
- Cause:** Corrosion or damage to the ground terminal ring from the coils to the engine block.
- Solution:** Carefully inspect and clean the ground rings and connections. Replace terminal rings if necessary.
- Additional Help:** Available from Davico Technical Assistance at 800-422-6046
Additional information: TSB PIP5232C
