2009 Chevy Truck Silverado 1500 4WD V8-6.0L

## #16-NA-383: Information on Rough Idle, Crank No Start, Extended Crank or Misfire Due to Excessive Carbon on Top of the Valves or Sticking Valves, Malfunction Indicator Light (MIL) Illuminated - DTC P0300, P0301, P0302, P0303, P0304, P0305, P0306, P0307, P0308 Set - (Jan 2, 2020)

This bulletin replaces PIP5029H. Please discard PIP5029H.

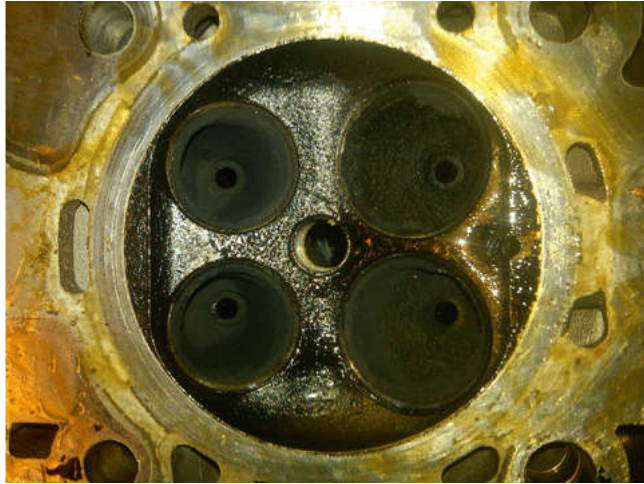
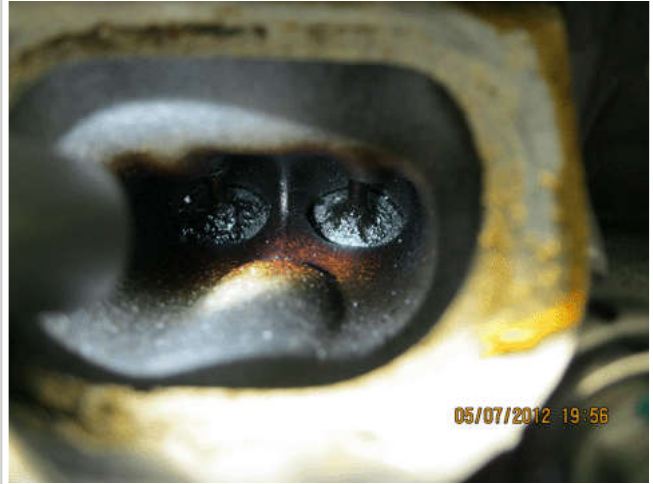
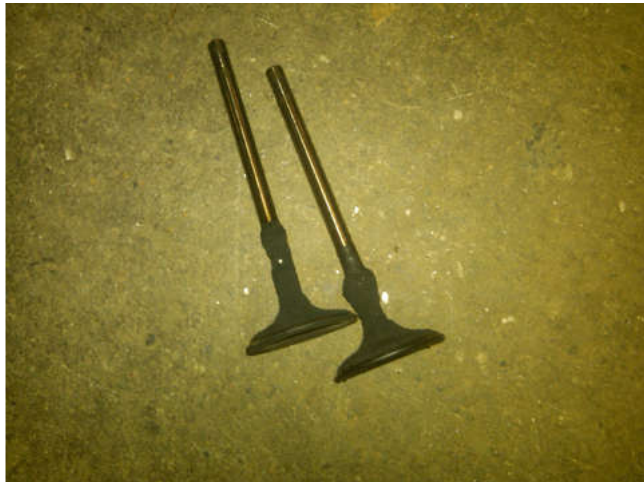
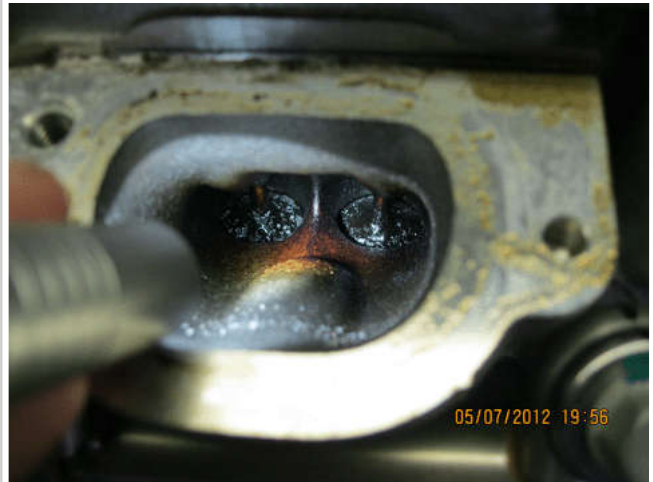
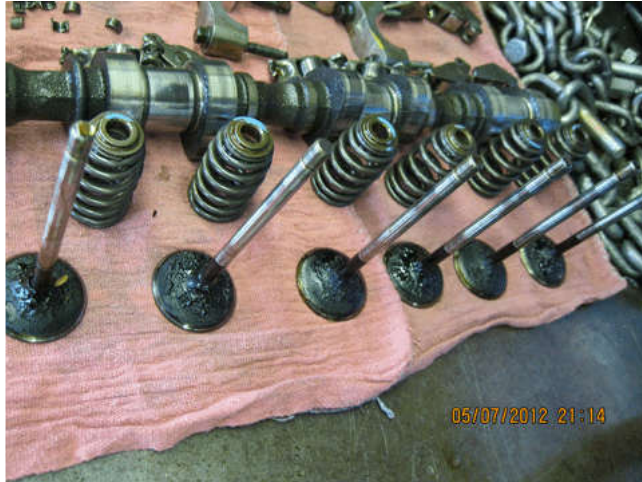
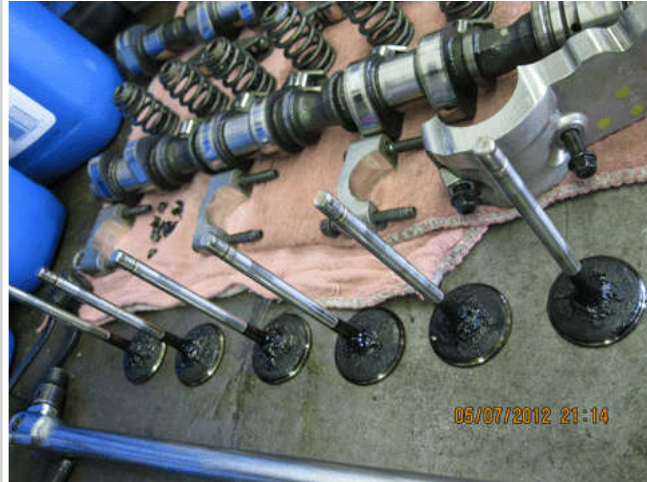
The graphics below may show typical carbon build-up during engine disassembly and inspection of the cylinder heads:

When the engine is cold, the compression on multiple cylinders may be at 0 kPa (0 psi).

The engine also may pop through the intake or exhaust while cranking and the spark plugs may be fuel-fouled when inspected.

Some engines may also experience valve damage or cam followers that are out of position as a result of this.

If this concern is encountered, perform SI diagnosis. If the SI diagnosis leads to a compression loss due to a valve sealing concern and/or eliminates everything else external to the engine, the following information may help:

- If there is no sign of valve damage or cam followers that are out of place, perform the following procedure to free up sticking valves and to remove carbon from the valves and pistons.
- If valve damage is present or if there are cam followers that are out of place, perform engine mechanical repairs as necessary to correct the concern and then perform the procedure below to prevent the concern from returning.
- Perform an upper engine and valve cleaning procedure.
- Below are examples of valves that have gone through a Top Engine cleaning procedure.

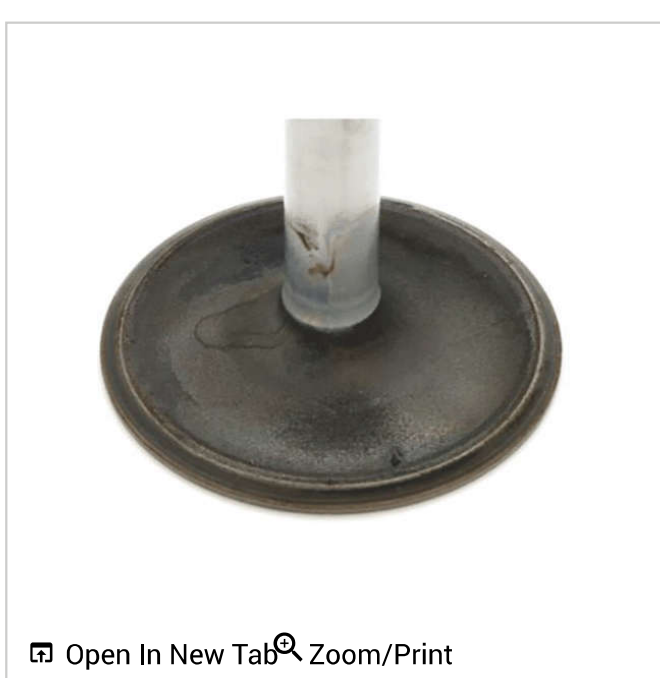
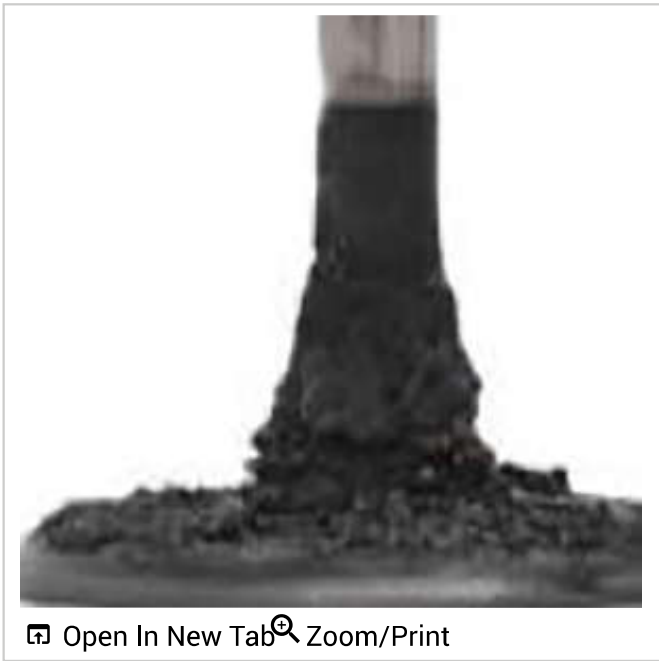
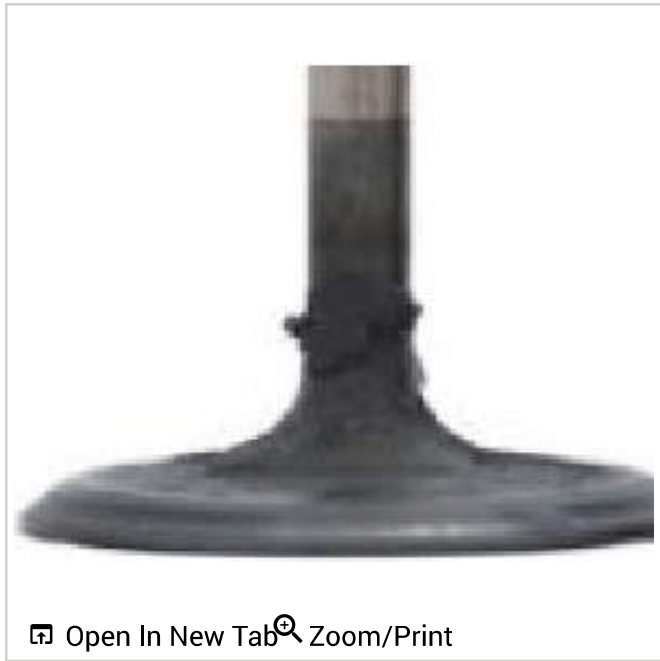
**Before Cleanup**

**After Cleanup**

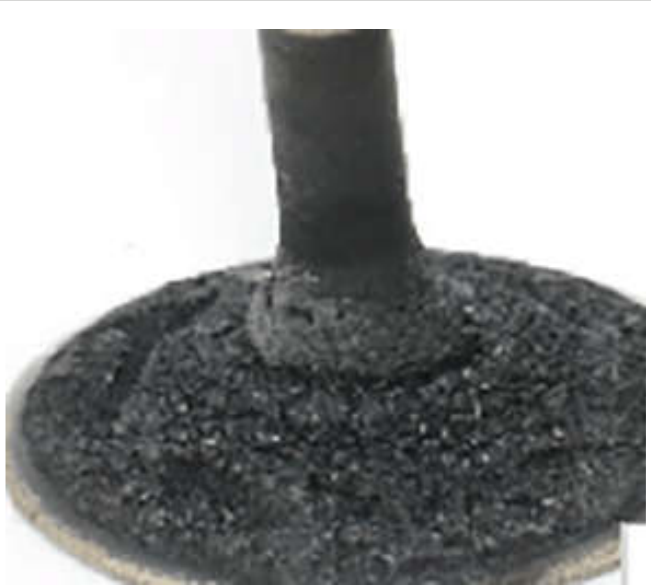
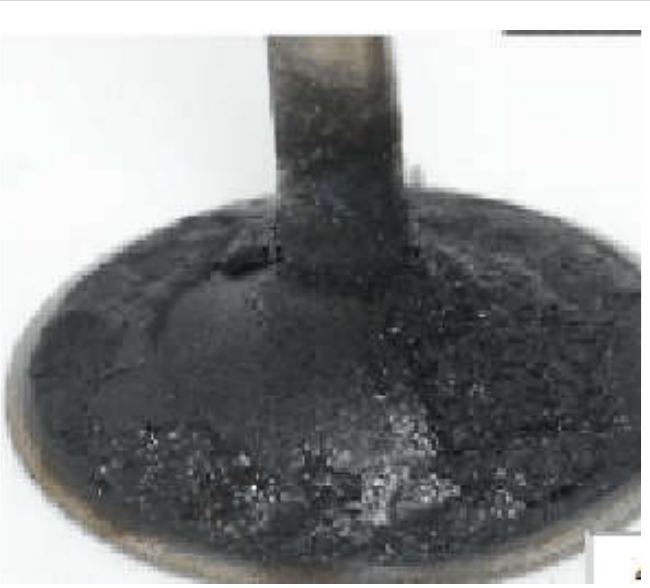
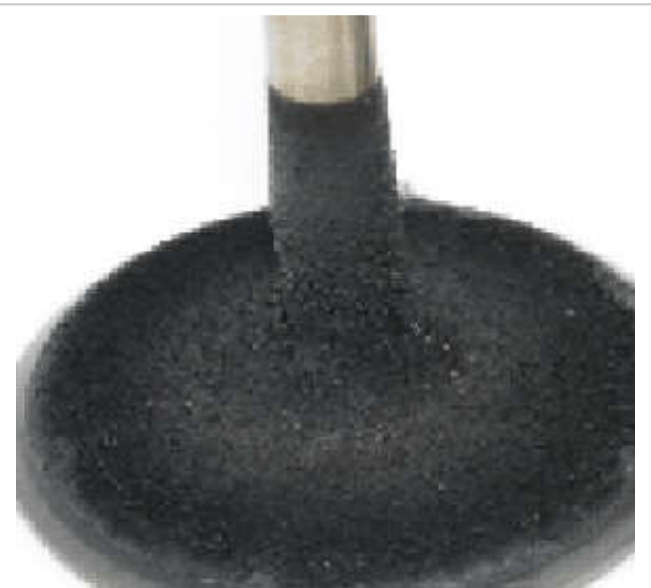
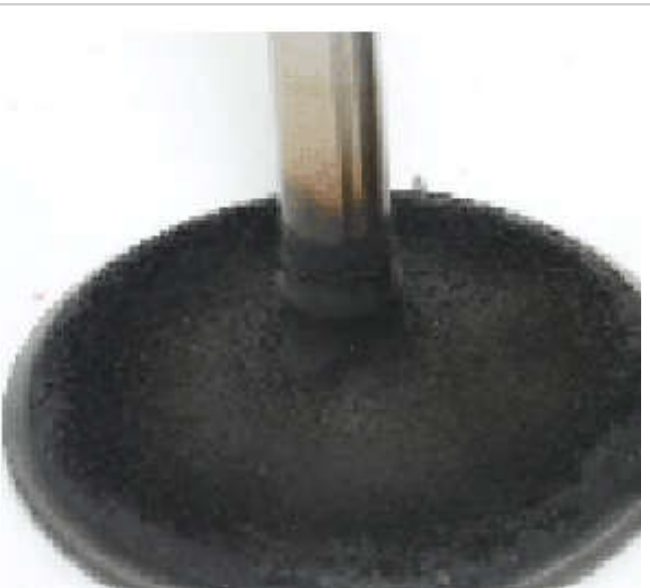
Before Cleanup	After Cleanup
